PhoenixTM Tines – Born in Fire

Since 1998 when the first practical carbide tipped coring tine was introduced [the *Dillennium* tine¹], the industry has been looking for a tine that would last as long but *not* have the problems associated with carbide tips. The PhoenixTM tine is the answer.

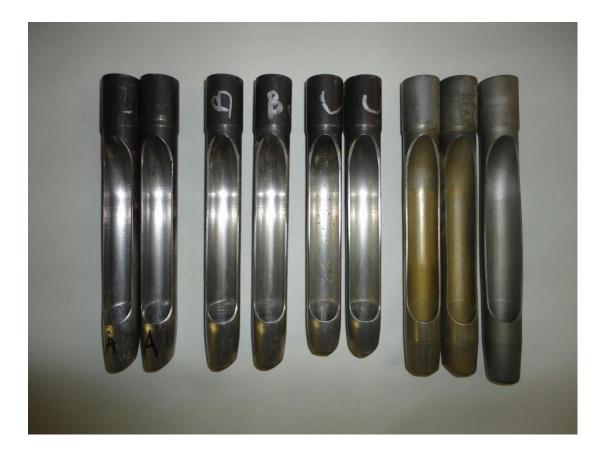
In late September 2011 Buffalo Hill Golf Course in Montana used three sets of CTI 1S-626075 (5/8" X 6") alongside two 5/8" Phoenix™ 1SP-626075 (5/8 X 6") tines over 27 holes. A new set of 1S-626075 (non-Phoenix™) tines was used on each of the three nine holes (marked as A, B, & C). 2 X 2" spacing was used to a 2.5" core depth on a Toro 648 aerifier. The same set of two 5/8" Phoenix™ tines was used on all 27 holes [180,000 sq. ft.], shown above on the right. Two representative examples of each set are shown above with an unused tine on the far right. Due to scheduling the aerification so late in the season carbide tipped tines could not be used according to the superintendent because it would cause 'turf-lifting'. The Phoenix™ tines had an average loss of length due to wear of 0.265" over the entire 27 greens. The 'nose' on each tine was 1.2" long, so 22% of the tine life was lost over the 27 greens with no loss of wall thickness. In the pictures above two non-Phoenix™ tines are shown from each of the sets used on each nine holes; on the far right are two used Phoenix™ tines (gold colored) and an unused 5/8" tine as an example.

Since the nose wall has thinned so much with less than half the original 0.0650" it is likely that had the tines been left on the machine they would have only been able to continue to pull cores for another three or four greens. Therefore, the Phoenix™ tines have a 'use-life' ratio advantage of 4:1 as compared to non-Phoenix™ tines.

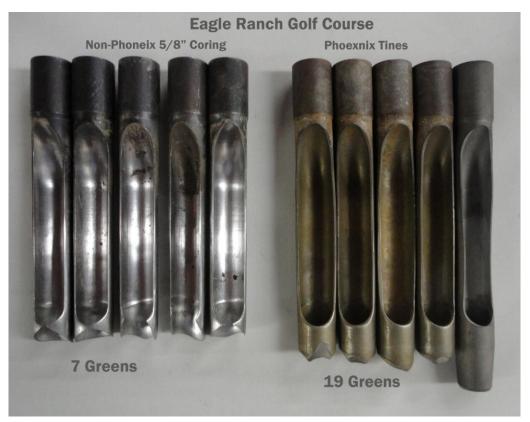
Eagle Ranch Golf Course in Eagle, Colorado used both Phoenix[™] and non-Phoenix[™] 5/8" X 6". Prior to the aerification they 'top-dressed' with a significant sand mix. This led to a situation of significant tine abrasion where the non-Phoenix[™] tines wore out and had to be replaced in just 5-6 greens [40,000 sq. ft.]. The Phoenix[™] treated tines completed all 18 greens and the putting surface and could have done more.
